**A SYSTEMS ENGINEERING PROCESS
FOR AN INTEGRATED STRUCTURAL
HEALTH MONITORING SYSTEM**

THESIS

AFIT/GSE/ENY/07-M02

**DEPARTMENT OF THE AIR FORCE
AIR UNIVERSITY**

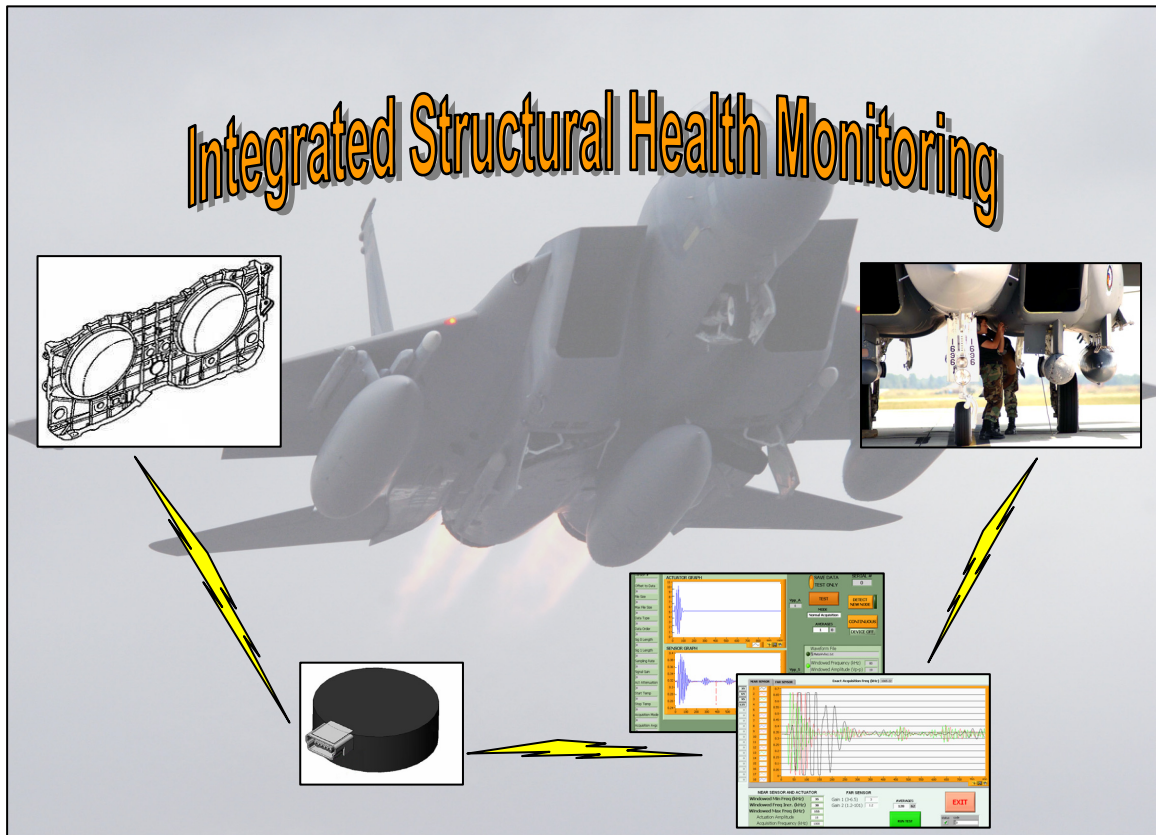
Figure 3.3: OV-1 Architecture

lightning bolts represent a generic form of interaction. The sensor then sends its data to a software program shown on the bottom right and the software is then used to generate maintenance action. Finally, on the far right side of the diagram, maintainers are performing the recommended action on the aircraft.

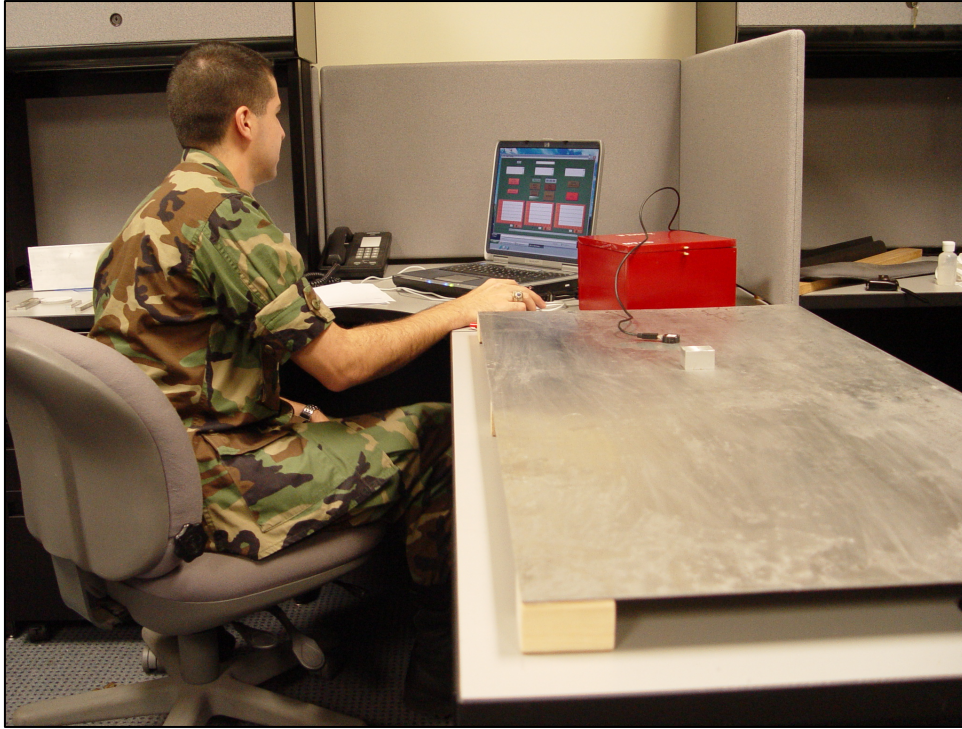
Figure 3.18: Picture showing the laboratory setup of the test plate

These sensors would be used for the pitch-catch method of testing. Again, damage would be simulated between the sensors, eventually progressing to actual damage as the technology is understood further. Now that the thesis group had chosen a sensor suite, the next step was to design the data collection device. Due to the requirements imposed on the data collection device, the group simply needed a laptop with a USB port and sufficient storage capacity. Finally, a software package would need to be designed for the system. One of the benefits of choosing this specific sensor was that the manufacturer had also developed a software package. This software package was able to read the data from the sensors and display it on the screen. It also saved the data in an array, making it easy to manipulate. The only portion of the software that needed to be designed further was the analysis package. The software that came with the sensors had no capability to input multiple signals from different tests for comparison. Capt Steve Crider had been working with these sensors on some different tests and had developed a Matlab code that would read in data files from a healthy and damaged specimen and display them simultaneously. It would also display a difference plot that was useful in determining where the damage was located. His software also allowed you to input the location on the plate that was damaged, and it would predict where the major differences would appear. Through data sharing and cooperation, the thesis group was able to use his code to generate test results in exchange for the thesis group running multiple tests for him to use. The entire lab setup is shown in figure 3.18

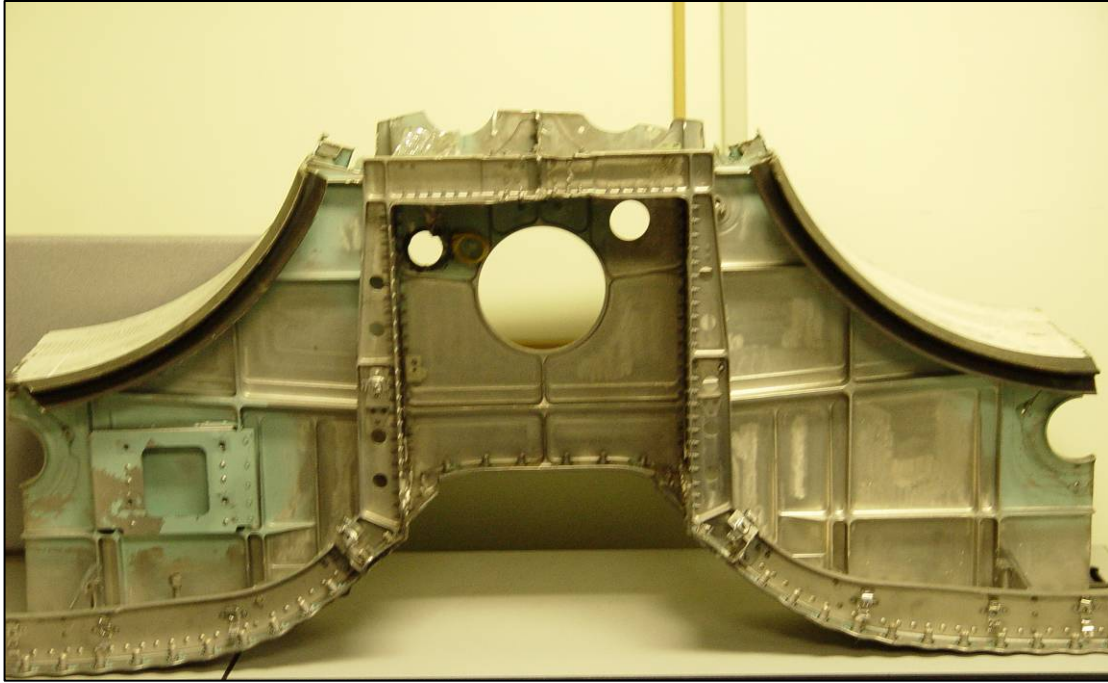
Figure 4.1: F-15 Bulkhead Section

As mentioned above, previous testing with the METIS sensor had verified the ability of the system to detect damage in a simplified structural element. The primary objective of this thesis group was to determine if the METIS sensor could function in a more realistic, i.e. more structurally complex environment. As described previously, the design driver for our ISHMS was the F-15 bulkhead crack discovered on a single operational aircraft and currently being studied. A secondary objective of this experiment was to try and determine just how sensitive the sensor was with respect to the size of the damaged area. Along the way the group would also be evaluating the software interface, and trying to establish any undesired correlation between our test methodology and the data produced. Initial discussions centered on the actual structural element that would serve as the platform for our testing. Several designs were produced with simplified versions of the bulkhead flange, shear web, and longeron attach joints. Producing a specimen that could be placed in a test cell and subjected to cyclic loading was briefly considered, but ultimately not pursued since it provided no direct benefit towards answering the main question of sensor capability. During this time frame a section of an actual F-15 bulkhead was requisitioned from the Aerospace Maintenance and Regeneration Center at Davis-Monthan Air Force Base. This bulkhead is shown in Figure 4.1

After the bulkhead section arrived at the lab it became apparent that the group would be unable to re-create the complexity of the structure. It had also become clear that no work had been done with these types of sensors in complex structural environments. All of the published work that could be located had been accomplished on flat plates in controlled environments. This included work currently being done at AFIT by Capt. Steve Crider, whose research would serve as a starting point for our own efforts. The thesis group ultimately decided to begin our experiments as in all previous cases, with a flat plate. The goal, however, would be to progress to a more structurally complex system while verifying the capability of the METIS sensor.

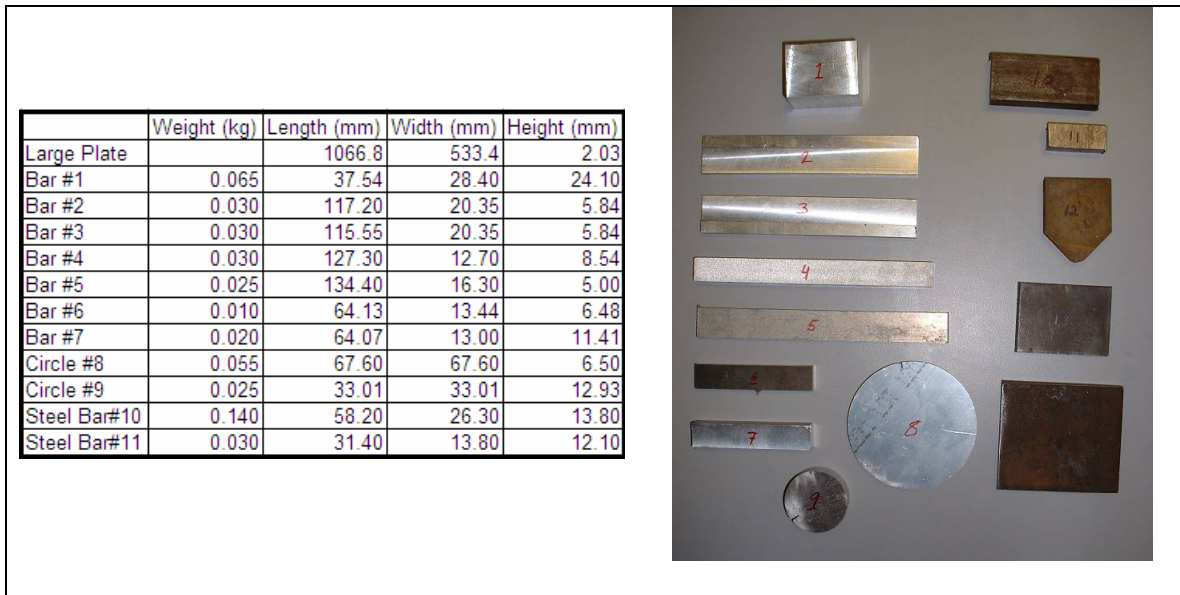
Figure 4.4: Blocks used for Simulated Damage Testing

As can be seen from the initial test matrix, a large amount of data was to be collected using the “simulated” damage method employed by Capt. Crider and others. Simulating damage to the plate offered several advantages, the most obvious of which was that the plate was not actually damaged and could be measured in its baseline state at the start of each test session. Another advantage was that many different combinations of damage could be explored, including the size, shape, and orientation of the damaged area, as well as any possible combination of damage types. A final and not insignificant advantage to simulated damage was that it allowed for operator training and familiarization with both the sensors capabilities and the software interface. For the purpose of damage detection using Lamb waves, simulating the damage condition can be accomplished in several ways. The basic principal is to create a highly localized change in the properties of the material, most notably, stiffness. This can be accomplished by the use of a clamp or vise, or even through the application of heat, but each of these methods carries a risk of permanently altering the plate. For our purposes, small aluminum or steel blocks (see figure 4.4) were placed on the surface of the test plate, using shear coupling gel to “attach” the two pieces. The addition of the block produces a localized change in stiffness of the plate which mimics an area of actual damage. The shear coupling gel allows the Lamb waves propagating through the structure to interact more effectively with the block, producing the best possible results in the data collected.

Once the initial learning curve was complete, a series of tests using blocks of various, size, shape and weight was conducted in an attempt to characterize the capability of the sensor with respect to the location, relative size and orientation of the "simulated" damage. Additionally, tests were conducted using multiple blocks in order to evaluate the ability of the sensor to provide distinct returns for more than one damaged area. After completing "simulated" damage testing, we proceeded to actually damaging the plate. There was obviously less flexibility when it came to actual damage, but the basic plan was to try and start with the smallest damage possible, and then to work up in size, with some changes in orientation and location to see how the results varied. The plan for actual damage included several locations which would eventually be drilled out, and were spaced to allow for the future addition of other structural members to the plate. This would be done in an attempt to build up the complexity of the overall structural element and increase the density of the baseline signal from which an area of new damage would have to be detected.

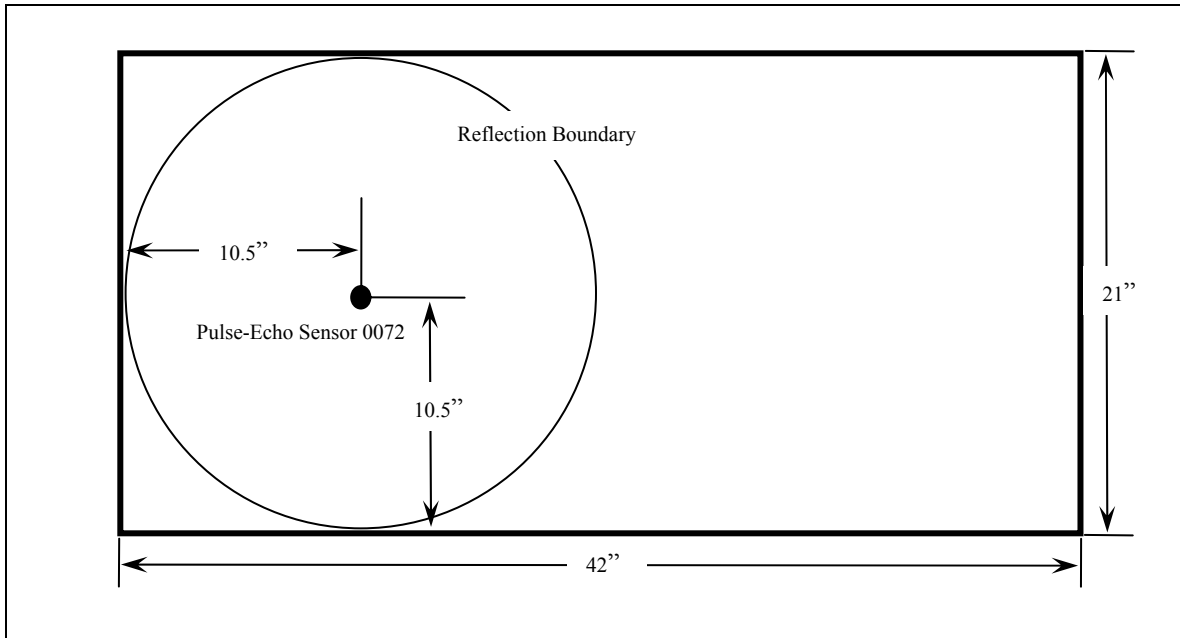
Figure 4.5: Large Plate with First Generation Sensor Installed

discontinuity in the plate, especially the edges, would produce strong reflections of the Lamb wave back to the sensor. On the square plate, these returns would all reach the sensor at the same time, producing a very predictable and regular data pattern that helped in analyzing subsequent information. In addition, the symmetric shape of the square plate actually caused a reduction in the number of reflections since any wave that didn't hit the edge of the plate perpendicularly was met by a similar reflection from an adjacent plate edge, and cancelled out. Although not as efficient as the purely square plate, the rectangular plate produced the same type of distinct reflection pattern. As mentioned previously, damage, or more precisely, a change in the material property of the plate, produced two unique phenomenon that were observed in the sensor data. The first was a reflection of the lamb wave off of the damaged area, which shows up in the data plot as change outside of the normal reflection pattern. The second change was caused by an absorption of energy from the Lamb wave as it passed by the damaged area twice, once as the wave passed the site outbound from the sensor, and once again on the way back to the sensor after being reflected from the edge of the plate. This effect was observed as both a change in amplitude in the normal reflection pattern, and as a shift in the timing of the reflection pattern, due to the attenuation of the frequency of the original signal. Of these two effects, the change in amplitude appeared to be more noticeable, possibly due to the relative size of the damage with respect to the rest of the plate. These phenomenon obviously continued to occur as the wave bounced back and forth multiple times from the edges of the plate and past the sensor, but we had concentrated our analysis to the primary reflection from the damaged area, and the primary reflection from the three closest edges. These reflections were the strongest and cleanest returns. For the

purposes of testing, the plate was divided into two areas, separated by what is referred to as the “reflection boundary” (see figure 4.5). This boundary was defined by a circle, centered on the sensor that extends to the 3 nearest edges of the plate.

Damage that occurs inside the reflection boundary will produce a reflection that should be observed before the first primary edge returns, and should produce attenuation effects within the primary edge return. Damage outside the reflection boundary should have no observable effect on the primary edge returns (or the secondary edge returns depending on the location of the damage). This result was important because it gave us a clue as to whether damage could be identified in a return signal from a more complicated structure, with multiple sources of reflections and interference. The final case occurs when the damage lies on the reflection boundary (or some whole number multiple of the reflection boundary distance) which will only generate a change in the edge returns. The group's initial test runs involved taking multiple sets of baseline data with the clean plate,

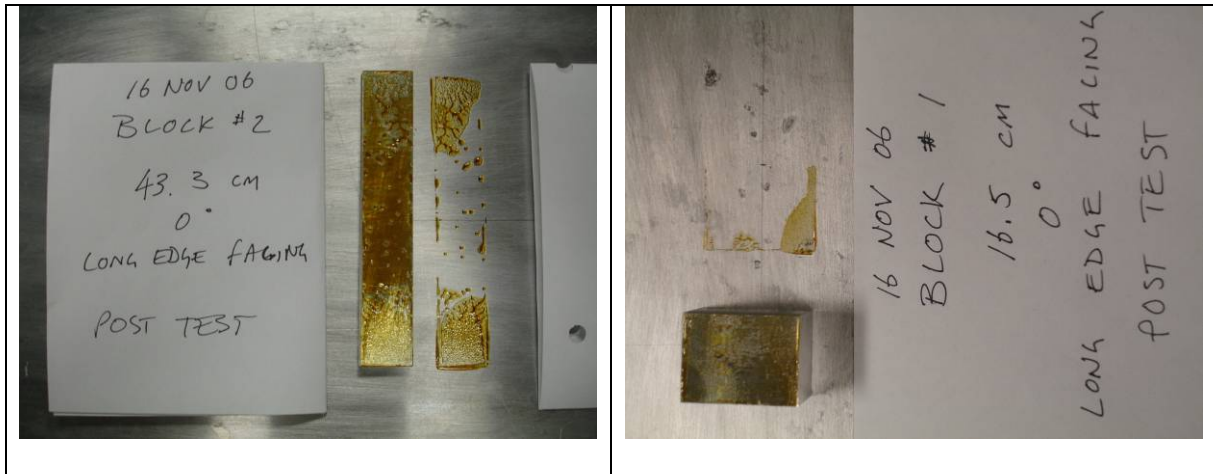
Figure 4.6: Post-Test Pictures Showing Partial Contact of Damage Blocks

blocks. This effect was first seen in some of the post-test pictures taken of the damage blocks after they had been removed (see figure 4.6).

The pattern of the shear gel on the plate gave the group a clear indication that the blocks were not making uniform contact with the plate, especially when they were placed along the center axis of the plate. After considering the problem, the group decided to address the problem by modifying the damage position. To address the contact issue, the group conducted a series of tests at different locations and orientations on the plate to minimize the effects of the sagging plate. In addition, a selection of steel blocks was obtained in order to increase the magnitude of the simulated damage by simply increasing the magnitude of the local change in stiffness of the plate. Although both of these changes produced the desired effects, the data plots generated using Capt. Crider's program did not show any significant improvement. At this point, the group had been resigned to the possibility that the first generation sensor simply did not have enough output capability to "see" damage in this large plate. The next step was to begin actually damaging the plate. Due to the groups' suspicions that the sensor might lack the output

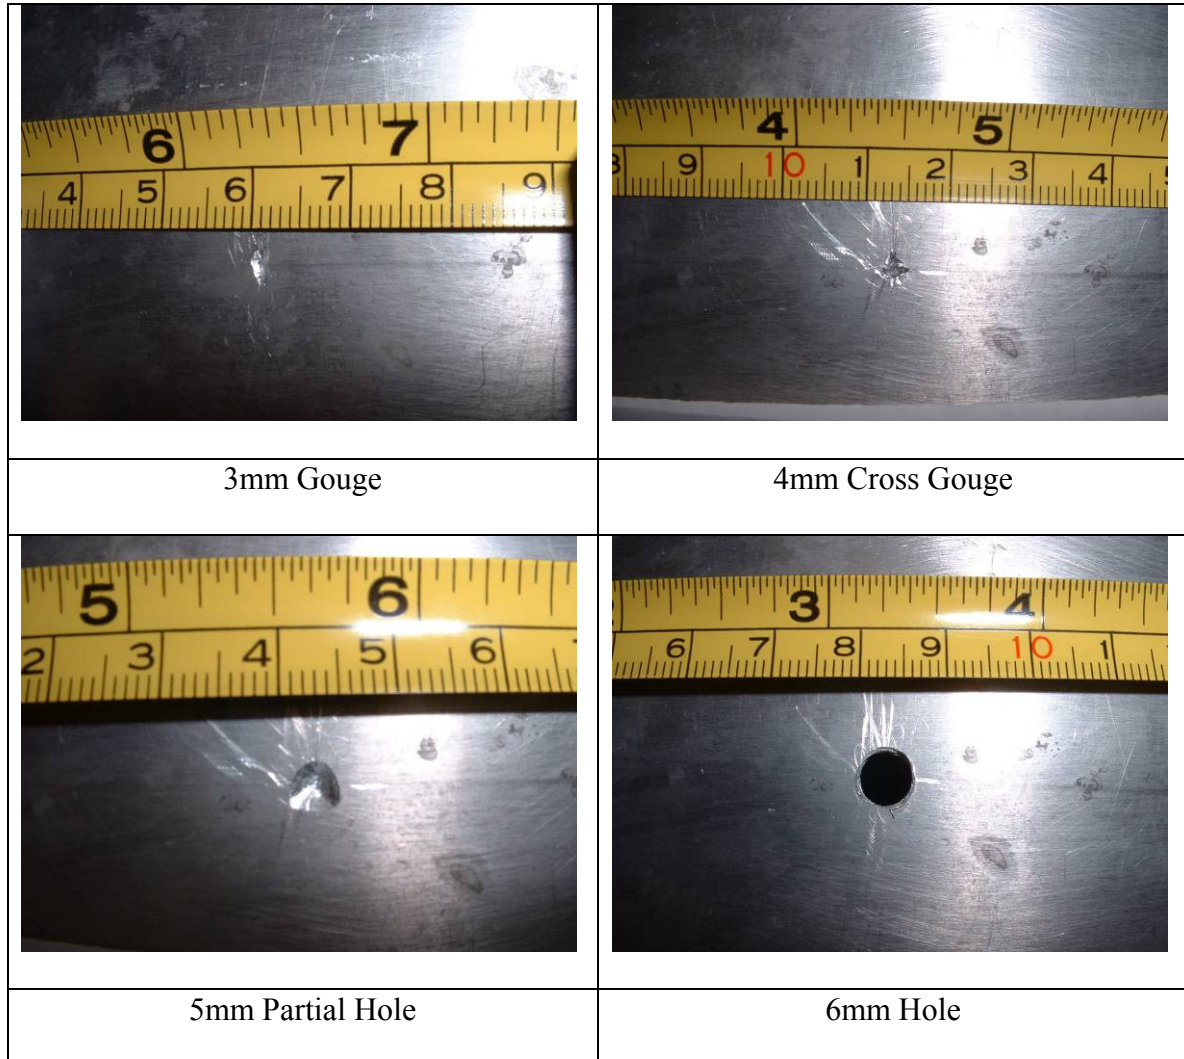
Figure 4.7: Actual Damage for initial Pulse-Echo Sensor Testing

necessary for this plate, the group elected to move our first damage location inside the reflection boundary in order to increase the chances of success. A total of four successively larger areas of damage were produced at the same location on the plate (see figure 4.7). Initial reviews of the data showed that the actual damage produced an even smaller return than the simulated damage blocks. In many cases, the group was unable to determine that any change had taken place to the plate at all. At this point the group was convinced that the sensor simply was not capable of producing a strong enough wave to illuminate the damage in the plate. More precisely, the changes in the wave produced by the damage in the plate were so small, relative to the original size of the wave, that we were unable to distinguish them from the background noise coming through the sensor. This had always been one of the biggest unknowns with regards to the usefulness of this sensor technology in an operational environment where background noise is a fact of life. To present both sides of the story, it must be noted that we made no attempt to control the background noise, nor did we make any attempt to try and filter the data to account for background noise. There are in fact, many methods in use which can effectively filter sensor data and highlight specific data ranges for analysis. Our overarching concept, however, was to maintain the simplest methods possible, and the highest level of data presentation in an attempt to establish the absolute capability of the sensor package.

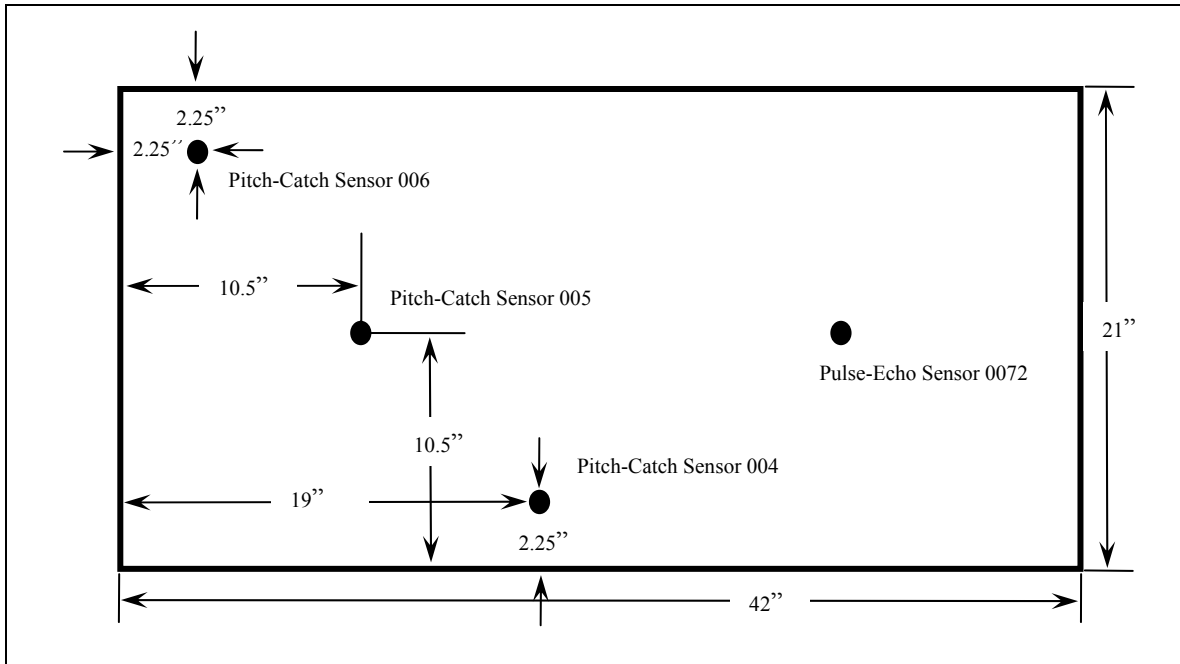
Figure 4.9: Large Plate with All Sensors Installed

plate, we chose to continue testing with our original plate, adding a total of three new sensors equally spaced as shown in figure 4.9. The location of the new sensors was chosen for two primary reasons.

First, using the same plate allowed for potential comparison of both the first and second generation of sensors using the same damage conditions. While this was in fact never accomplished, the potential was seen as a benefit towards using the same plate.

Our primary test location was between sensors 005 and 004. Most tests were conducted using sensor 005 as the actuator and sensor 004 as the recorder. The software interface provided with the sensors only supported two sensors during any given test. This turns out to be a fairly significant limitation to the overall concept of operations since there are many scenarios where the same signal recorded at multiple sensor locations can provide information with respect to the location of the damaged area. Another operating constraint to the software interface was the speed at which the tests were conducted. The software could be set up to run a sweep of all the selected frequencies. Using the 128 average setting that we had selected, one run would take approximately one hour to complete. The simple fact of not having enough time available to complete multiple runs kept us from taking any significant amount of data using sensor 004 as the actuator, and prevented us from using sensor 006 at all. Based on the results of earlier testing we modified our test matrix for Pitch-Catch (see figure 4.10).

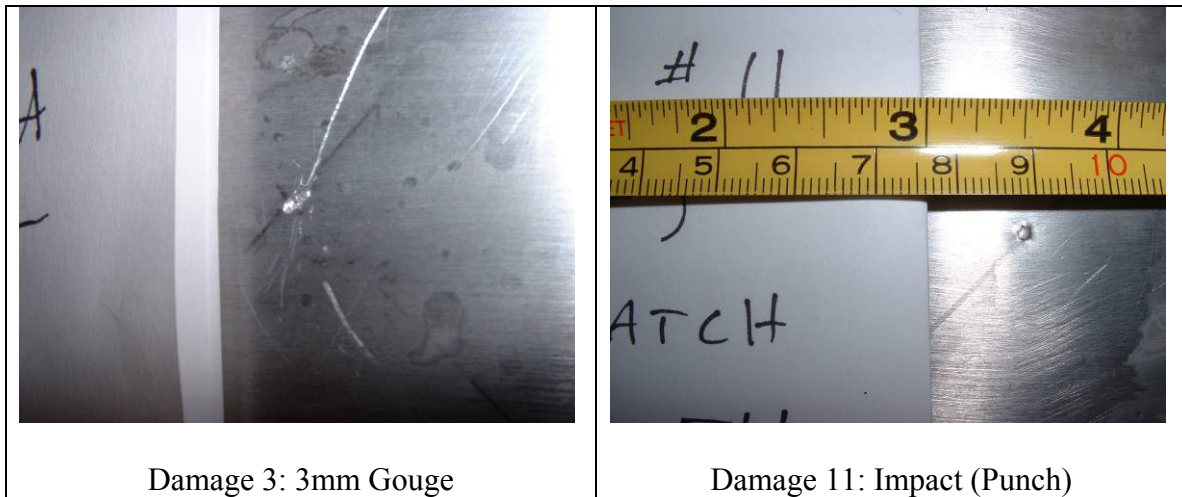
Figure 4.11: Damaged Areas

Subsequent damage was added to the plate at two locations offset from the line between sensors 004 and 005. The resulting damage locations formed a line perpendicular to the line intersecting sensors 004 and 005. Several types of damage were added to the plate. A chisel was used to gouge the surface of the plate, providing the closest analogy to a crack that we had the means to inflict. Impact damage was also simulated by means of a punch (Figure 4.11). Finally, the damaged areas were drilled out using a 1/16" drill bit, followed by a 1/4" drill bit. Once these three locations were drilled out, a stiffener was added to the plate to increase the structural complexity of the system.

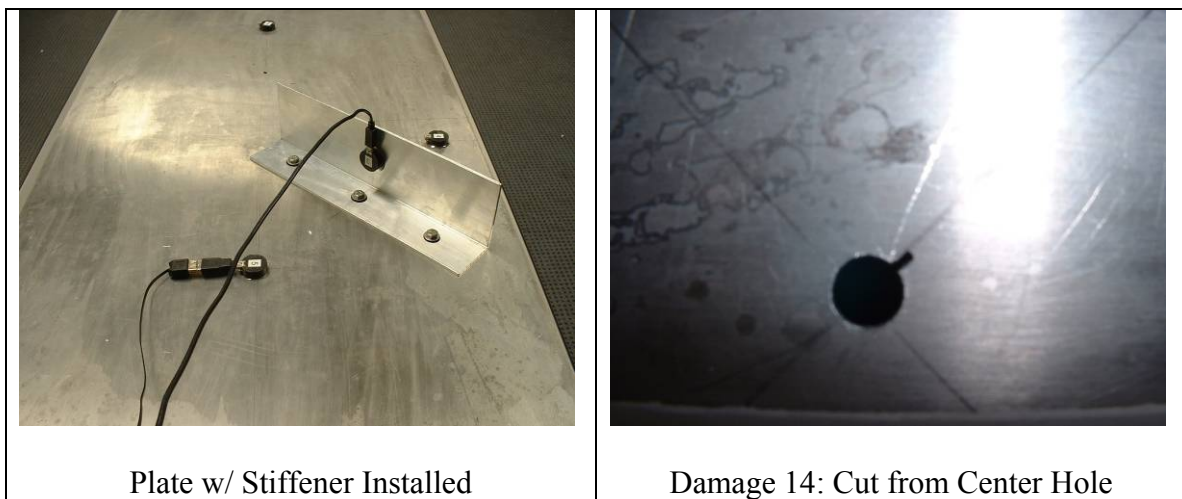
Figure 4.12: Damage Testing w/ Stiffener Installed

At this point, additional damage was added to the plate between the stiffener and sensor 005, and under the stiffener, originating from the center hole location. This final configuration would provide the answer to the question of whether or not the sensors had the capability to detect damage in a more structurally complex environment (see figure 4.12).

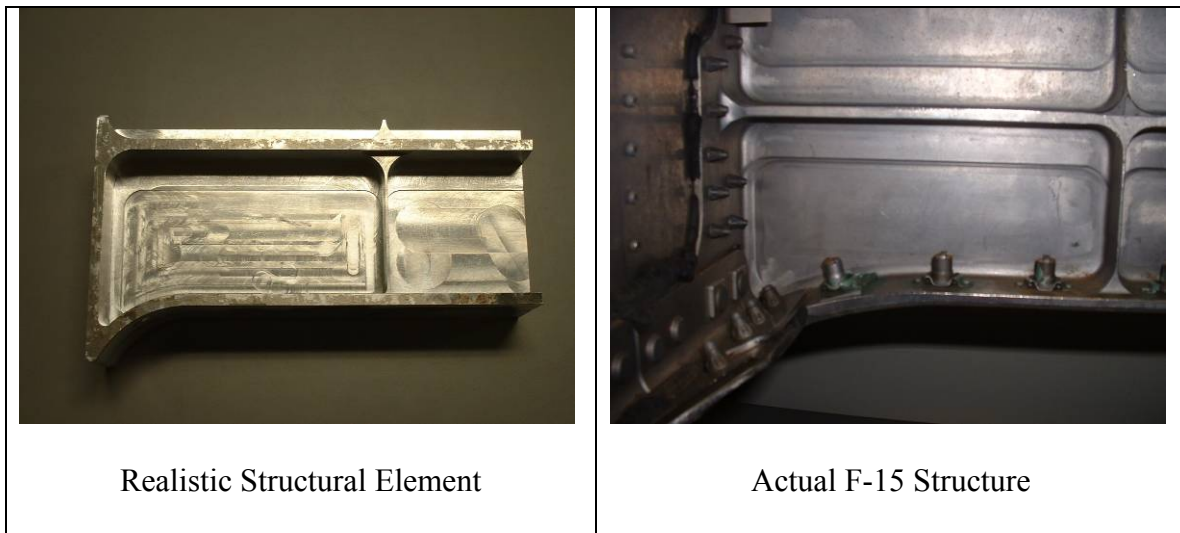
Figure 4.14: Possible Specimens for Future Sensor Testing

Although somewhat limited in scope the testing completed by this thesis group does allow for several important conclusions with respect to damage detection using Lamb wave technology, and the METIS sensor package in particular. The first and most obvious conclusion is that there is potential for this technology and for the METIS sensor to be used in structurally complex environments. This conclusion will require further validation on ever increasingly complex test specimens (see figure 4.14)
